CALIFORNIA DIVISION OF MINES AND GEOLOGY  
FAULT EVALUATION REPORT FER-237

**SPRINGVILLE, CAMARILLO AND RELATED FAULTS**  
in the Camarillo and Santa Paula Quadrangles  
Ventura County, California

by  
Jerome A. Treiman  
September 23, 1997

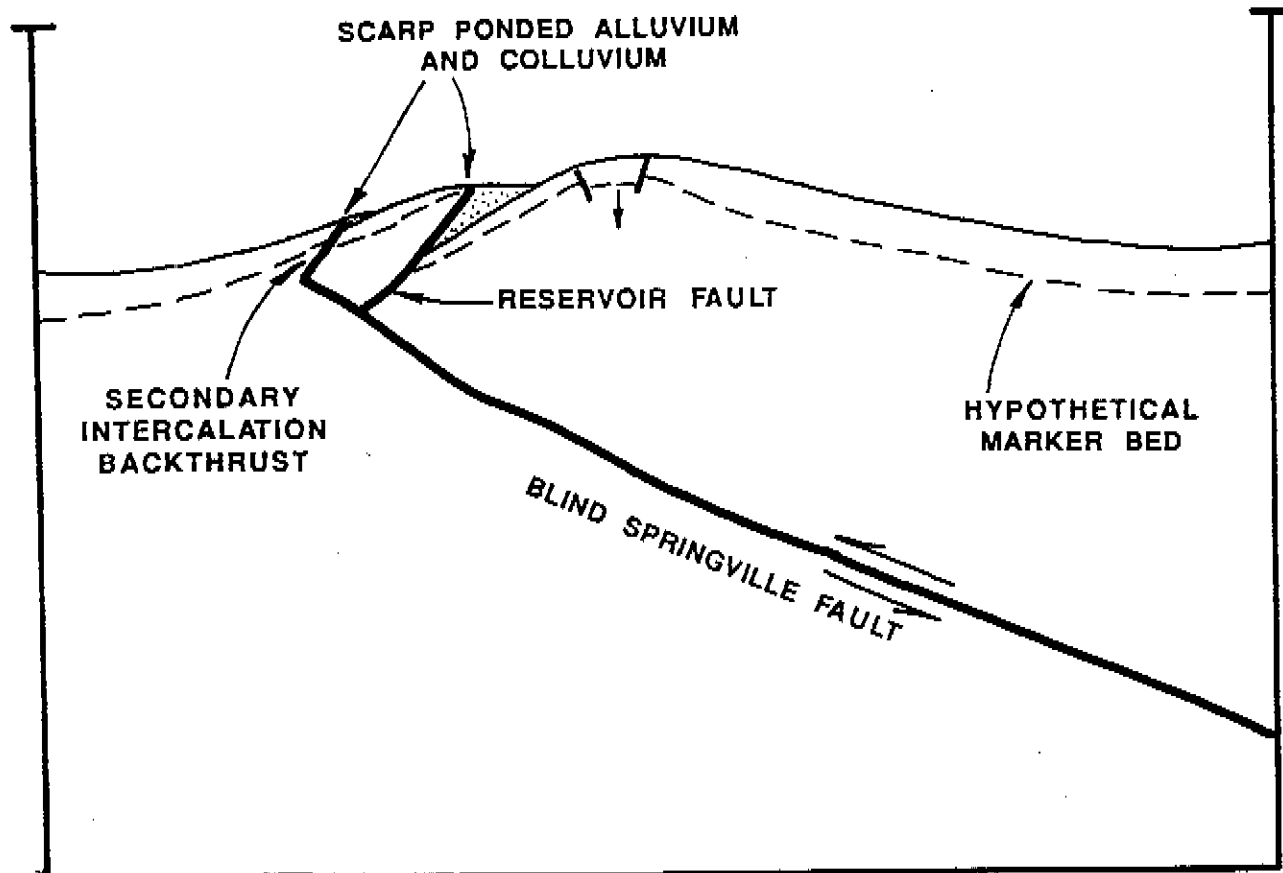
Among the backthrusts investigated by Leighton & Associates (1993), the most prominent is the "Reservoir fault" with as much as 145 feet of vertical offset (drag folding included). This fault was determined to not be active, based on soil stratigraphy and structural interpretation. The Reservoir fault was modeled as an intercalation backthrust (see Figure 3) that ceased to be active once the Springville fault broke past it, about 30,000 years ago. The youngest unit offset by the Reservoir fault is a paleosol that is about 32,000 years old. An argument is presented that this subsidiary fault has not responded to at least 10 subsequent events on the Springville fault (Leighton & Assoc., 1993), although the number of events may be half this amount. Lesser backthrusts behind the main trace, yet well south of the Reservoir fault, are younger, having formed as the Springville fault propagated to the south. Leighton & Associates (1993) determined that the minor backthrust above their western *en echelon* fault segment was no longer active but that the backthrusts above their eastern *en echelon* segment are still active (or reactivated).

**Figure 3 (FER-237)** - Illustration of an "intercalation backthrust" wherein the thrust front has intercalated, or inserted, itself between layers of colluvium and bedrock. The uplifted portion of colluvium and bedrock lies above the backthrust. (*Illustration from Leighton, 1993, figure 5*)

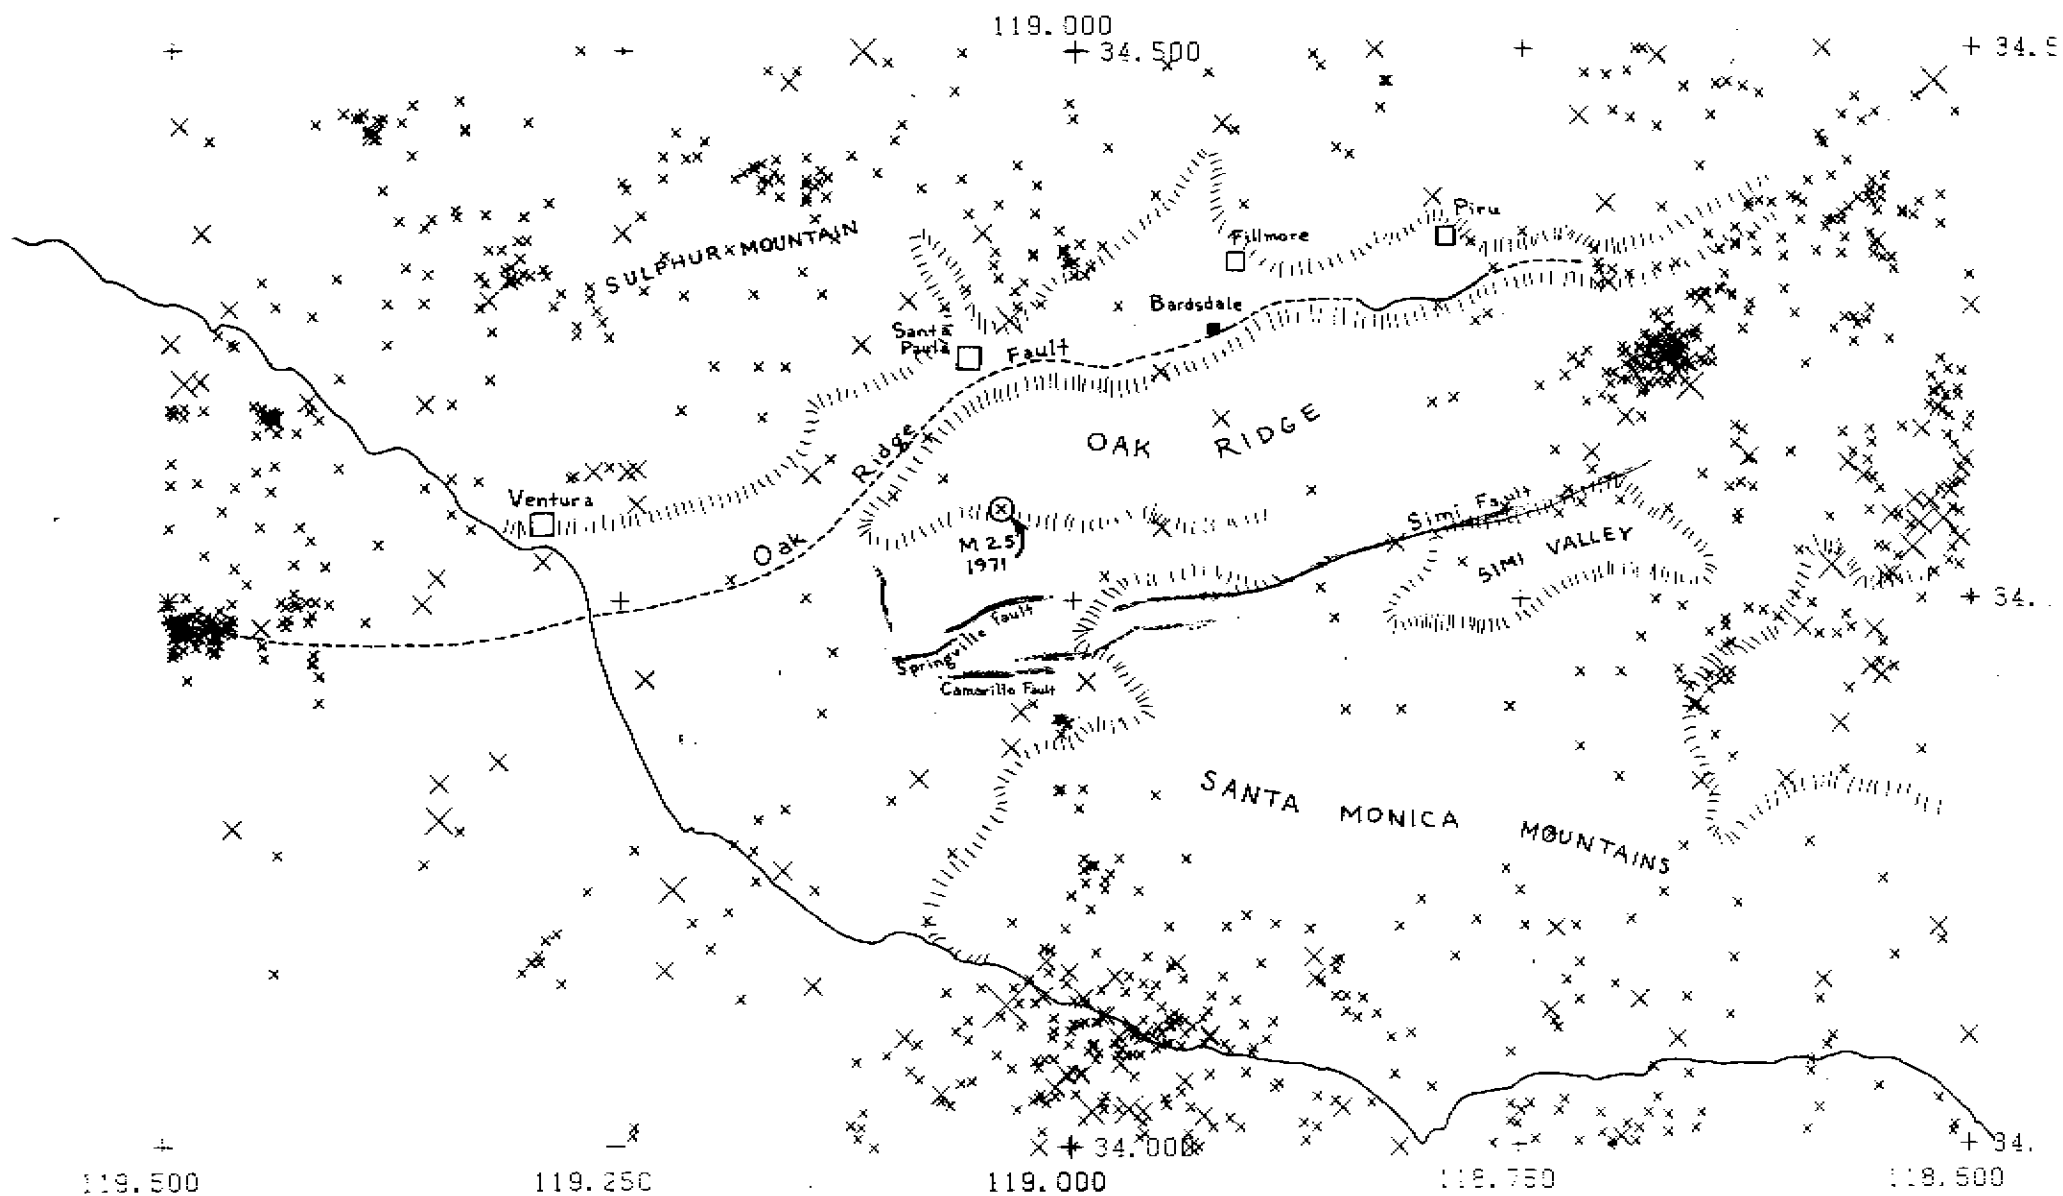
**Figure 5 (FER-237) - Seismicity from 1932 to 3/16/89, M1 and greater. (CalTech earthquake catalogue)**

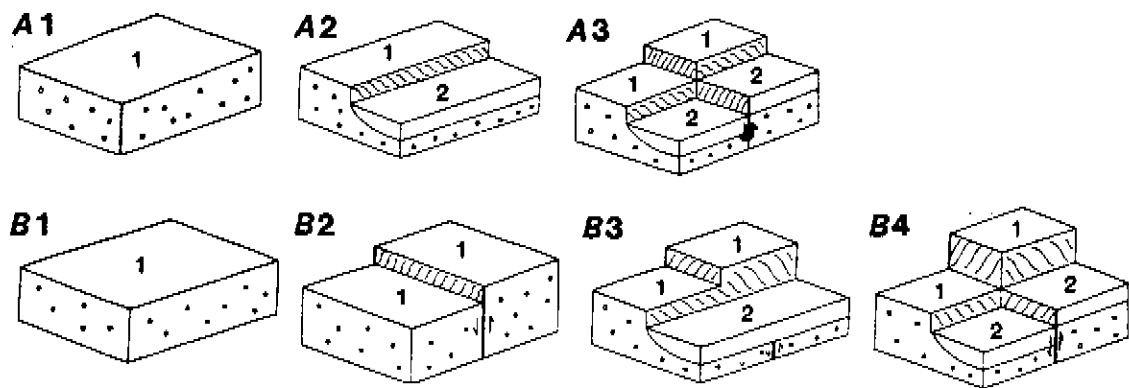
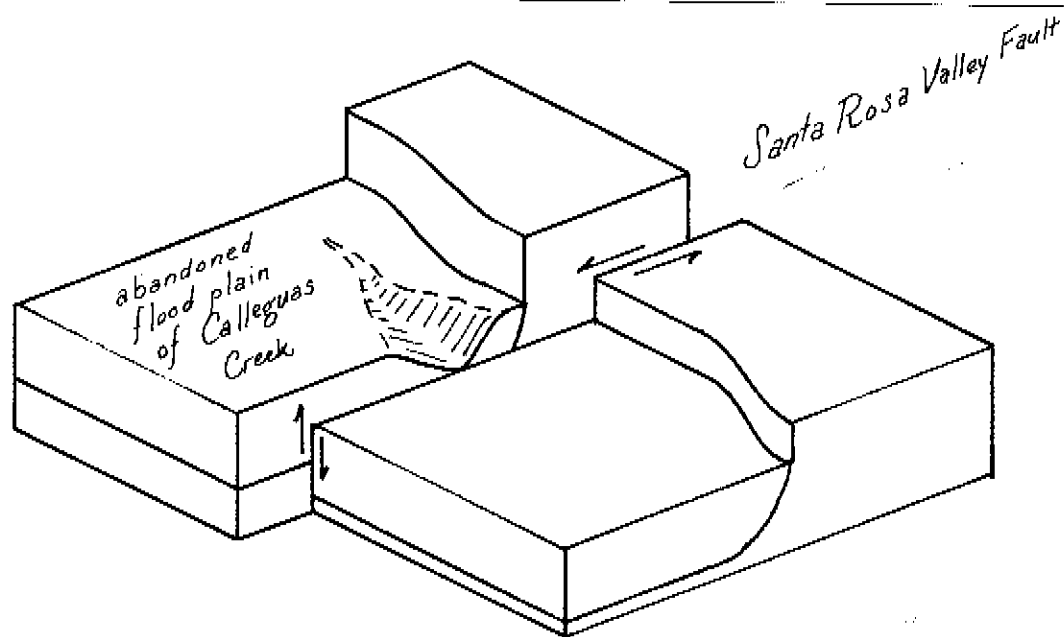
indicates that prior to grading there was a 15'-high escarpment that was approximately 120' wide, making it a distinct, but not sharp, feature. (That map is on file with the City of Camarillo. At the time of the mobile-home park development this escarpment was not investigated for possible faulting.) The fact that the scarp appears much sharper in the aerial photography than is represented on the grading plan may be explainable by agricultural land-use prior to development. Immediately to the east, where the fault projects along the base of a hillslope, an older north-south trending channel-cut projects north directly into the hillslope, suggesting 100'-150' of left-lateral displacement. The channel cut is not well defined north of the scarp, probably because the stream was better able to cut a vertical bank in the Pleistocene alluvial deposits to the south. The nearly right-angle juncture of the scarp with the paleo-stream bank argues against an erosional origin for the scarp. This is in contrast to the more obvious, curving meander cut one mile to the west. These geomorphic relations typify fault/stream bank offsets as illustrated in Figure 6 (after McCalpin, 1987).

--Schematic block diagrams of fault scarp/ terrace relations. A. earlier alluvium (1) is deposited, younger terrace (2) is incised into it, then a single faulting event occurs. B. Earlier alluvium is deposited (1), then faulted (2). After faulting a younger terrace is incised into both the upthrown and downthrown blocks (3), then is re-faulted along the same trace (4). The multiple-event scarp on terrace 1 is twice as high as the single-event scarp on terrace 2 if displacements are equal.

**Figure 6 (FER-237)** - Upper illustration from McCalpin (1987) showing topographic relationships between faulting and stream terraces. Note that this figure presents a mirror image of the situation at the Calleguas Creek/Santa Rosa Valley Fault intersection. Minor left-lateral displacement is also needed to result in the lower sketch.

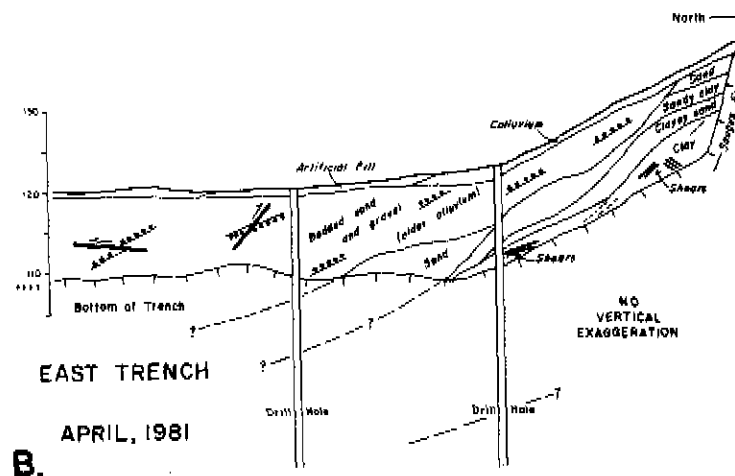
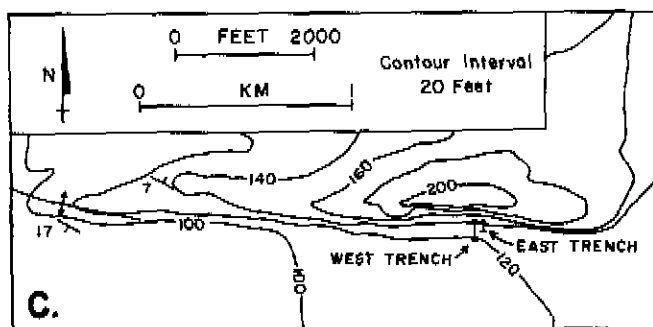
Figure 10 (FER-237) - from Gardner (1982)

Detailed studies along the Camarillo fault have located only subsidiary "bending moment" faults, which are considered to be secondary to the main structure (an inferred high-angle north-dipping reverse fault) that may not reach the surface. Gardner (1982), citing oil well and other data, infers that the fault dips north at approximately 80°. Trenching by Gardner (at the western edge of section 36; see Figure 10) revealed Pleistocene and possibly younger deposits that are locally tilted southward up to 45°. Within these deposits are north- and south-dipping shears with from 1 inch to 6 inches separation, that are interpreted to be "bending moment faults" above the main buried fault (Gardner, 1982; Yeats, 1982). An unpublished investigation south of the 101 freeway near Carmen Drive (in section 35; Geolabs, 1990d; cited by Blake, 1991) revealed south-dipping reverse faults which Blake interpreted as bending-moment faults. On one fault, displacement within the Pleistocene deposits diminished upward, from 25" to 12" within a 6-foot long section of the fault (see Figure 11). Groundwater data from Ventura County (1975) suggested that the fault dies out along the westerly plunging anticline that forms the ridge.

(Figure 6a, b.) Simplified sketches of trenches across Camarillo fault, after D. A. Gardner (this volume, and unpublished technical reports by Geotechnical Consultants, Inc.). c. Topography of ridge in downtown Camarillo from U.S. Geol. Survey Camarillo 7½-minute quadrangle, locating two trenches. Camarillo fault is presumed to control steep south flank of this ridge. d. Sketch of presumed relation between bending-moment faults in trenches and subjacent Camarillo fault.

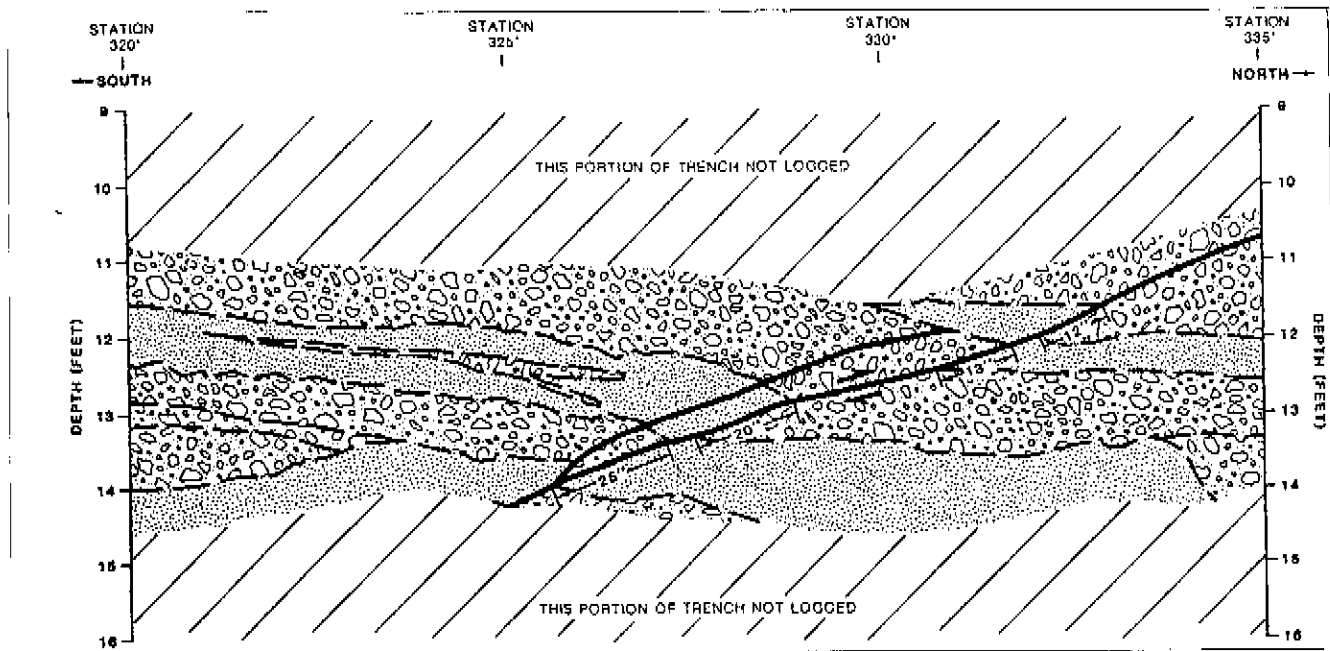
**Figure 11 (FER-237)** - Sketch log of a trench excavated by Geolabs (1990d). "The faults exposed in the trench are interpreted to be dying-out-upward bending-moment faults. Note that the slip along the lower fault diminishes from 25 inches near base of trench to 12 inches near top, suggesting that perhaps slip may have been accommodated by warping, dilation, and intergranular rotation in the poorly lithified near-surface materials" - quoted from Blake (1991, his fig.8, location G).
